Appendix A

Site Profile Sheets

**Broome County BOA
Descriptive Site Profile**

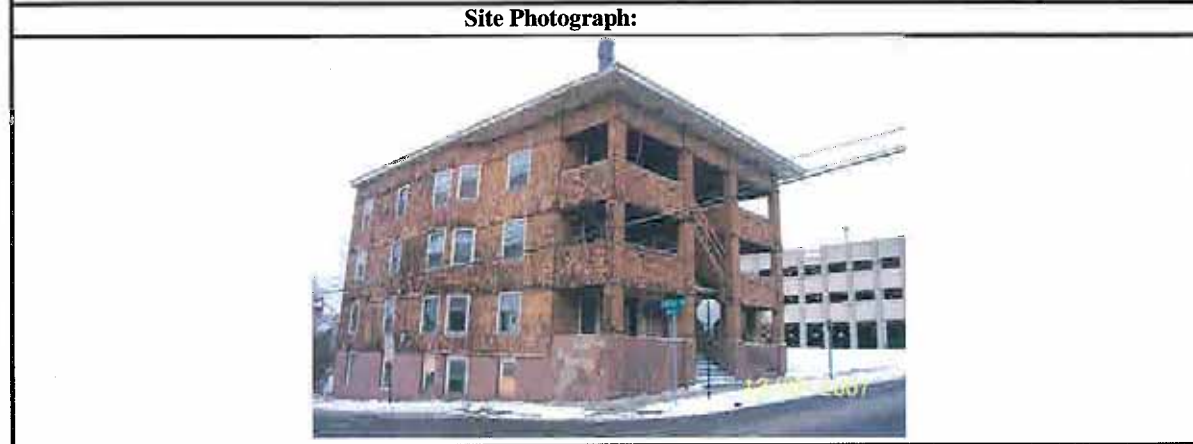
Buildings					
Number:	Square Footage:	Stories:	Year Built:	Construction Type:	Condition:
1	5328	3	1965	Wooden	Poor

Date: 12/5/2007	
Current Use of Property	
The property currently appears to be vacant and run down and most recently used for residential purposes.	
Adjacent Land Use	
North:	Hospital parking garage South: Vacant Masonry Building (80 Arch st)
East:	Residential West:
Physical Features	
<i>Soil Information:</i>	Cut and Fill Lands, gravelly and silty materials
<i>Surficial Geology:</i>	Outwash Sand and Gravel
<i>Geologic/Bedrock:</i>	Cashaqua Shale of the Sonyea Group
<i>Topography:</i>	Flat, gently sloping to south
<i>Inferred Groundwater Flow Direction:</i>	To the south towards the Susquehanna River
Site Inspection Notes	
Due to lack of access to the property site inspections were performed by viewing the site from adjacent roadways/parking lots. No interior inspections were performed. Recent snowfall prevented ground surfaces from being observed.	
<i>Evidence of hazardous waste treatment, storage, disposal</i>	__ Yes <u>X</u> No

Historical Atlases	
Source:	Combination Atlas Map of Broome County, 1870.
Description:	No coverage for the site, however areas south and east were already developed.
Listed Spills (Database Search)	
Description:	
No concerns noted for this property based on the Environmental First Search Database Report.	
Summary of Environmental Concerns	
There were no documented concerns identified in the database report, and historic research indicated only usage for residential purposes. This type of use would not indicate the likelihood of environmental contamination at the site, however further investigation would need to be performed to rule it out.

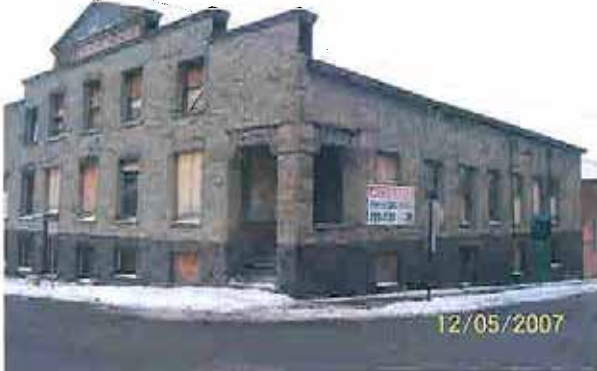
Site Photograph:

Date: 12/5/2007
Current Use of Property	
The property is currently vacant. Historic research indicates that it had previously been occupied by Lescron Enterprises Inc, and Felters Co. It is located between an abandoned warehouse district, and many of the healthcare buildings associated with Wilson Hospital	
Adjacent Land Use	
North: Residential, parking and healthcare facilities.	South: Parking facilities for the hospital.
East: Vacant portion of the lot at 96 Corliss.	West: Parking facilities for the hospital.
Physical Features	
<i>Soil Information:</i>	Cut and Fill Lands, gravelly and silty materials
<i>Surficial Geology:</i>	Outwash Sand and Gravel
<i>Geologic/Bedrock:</i>	Cashaqua Shale of the Sonyea Group
<i>Topography:</i>	
<i>Inferred Groundwater Flow Direction:</i>	To the south towards the Susquehanna River
Site Inspection Notes	
Due to lack of access to the property site inspections were performed by viewing the site from adjacent roadways/parking lots. No interior inspections were performed. Recent snowfall prevented ground surfaces from being observed. No surface water features, hazardous substances, petroleum products or storage of hazardous materials was noted.

While there were no reports associated with this property in the database report, historically the property was used for industrial purposes. Given the past usage, as well as its presence in a historically industrial area, the potential for soil/groundwater contamination at this site does exist.

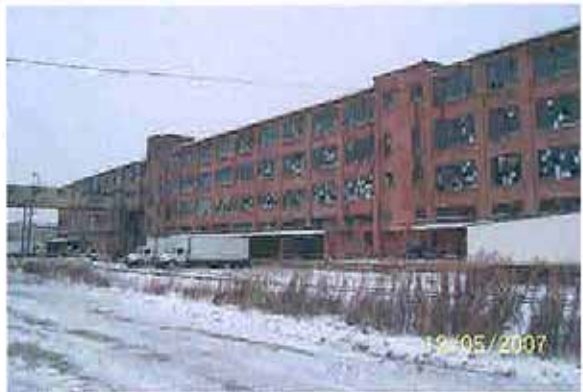
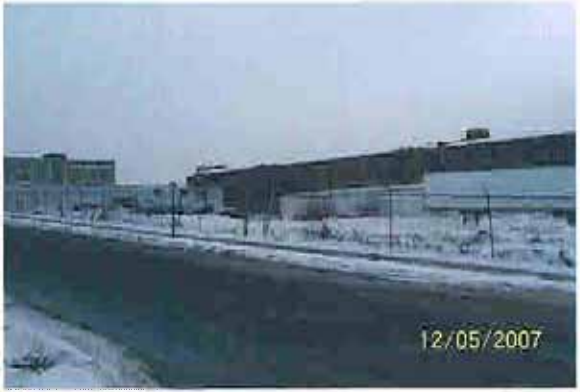
Date: 12/5/2007
Current Use of Property	
The property currently has several uses. The large brick warehouse building as well as the adjacent metal building appear to be used as a transfer station for recyclable materials by Empire Recycling. The two newer metal buildings on the north side of the site are home to Indian Valley Industries and appear to be a more economically viable business than the other tenants on the property. Several tractor trailers are stored in a vacant area in the northwest corner.	
Adjacent Land Use	
North: Corliss Ave, Residential	South: Railroad tracks, warehouse buildings.
East: Employee parking for Wilson Hospital.	West: Warehouse and industrial areas.
Physical Features	
<i>Soil Information:</i>	Cut and Fill Lands, gravelly and silty materials
<i>Surficial Geology:</i>	Outwash Sand and Gravel
<i>Geologic/Bedrock:</i>	Cashaqua Shale of the Sonyea Group
<i>Topography:</i>

While there were no reports associated with this property in the database report, historically the property was used for industrial purposes. Given the past usage, as well as its presence in a historically industrial area, the potential for soil/groundwater contamination at this site does exist.

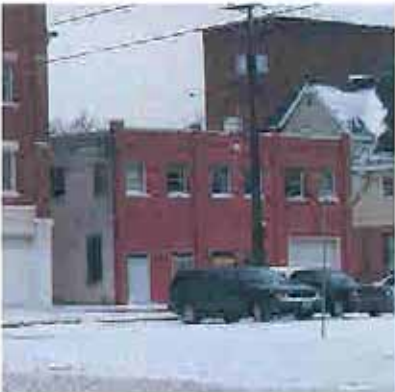
Site Photograph:

Date: 12/5/2007	
Current Use of Property	
The sign outside the building lists it as The Firehouse Stage, a theater. The architecture of the building shows that it was once used as a fire station. City directories indicate other uses as a municipal building, and occupancy by the police department and the Grand View Hotel.	
Adjacent Land Use	
North: Commercial.	South: The Firehouse Stage.
East: A Park.	West: Residential.
Physical Features	
<i>Soil Information:</i>	Cut and Fill Lands, gravelly and silty materials
<i>Surficial Geology:</i>	Outwash Sand and Gravel
<i>Geologic/Bedrock:</i>	Cashaqua Shale of the Sonyea Group
<i>Topography:</i>	
<i>Inferred Groundwater Flow Direction:</i>	To the south towards the Susquehanna River
Site Inspection Notes	
Due to lack of access to the property site inspections were performed by viewing the site from adjacent roadways/parking lots. No interior inspections were performed. Recent snowfall prevented ground surfaces from being observed. No surface water features, hazardous substances, petroleum products or storage of hazardous materials was noted.

There were no documented concerns identified in the database report, and historic research indicated did not indicate industrial use. It is believed that this property was used by the police and fire departments. This type of use would most likely include the presence of fuel tanks (for equipment), and while no spill reports exist, the past/present existence of tanks cannot be completely ruled out without further investigation, which is needed to determine the likelihood of contamination on the site.

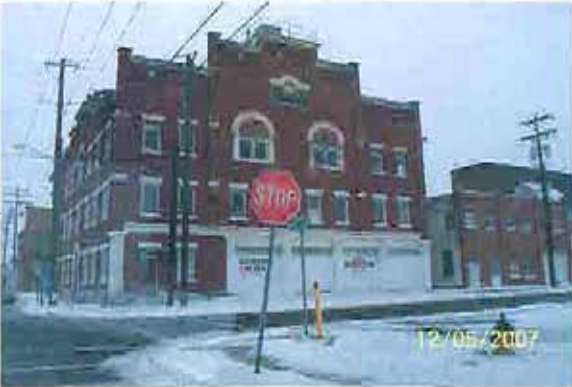
Site Photograph:

Date: 12/5/2007	
Current Use of Property	
The property did not have any signs indicating is use. It does appear to be occupied but the usage does not appear to be industrial or manufacturing. It is next door to the Goodwill Theater at 42 Willow St.	
Adjacent Land Use	
North:	Commercial, Residential. South: Indian Valley Industries.
East:	A small park. West: Residential.
Physical Features	
Soil Information:	Cut and Fill Lands, gravelly and silty materials
Surficial Geology:	Outwash Sand and Gravel
Geologic/Bedrock:	Cashaqua Shale of the Sonyea Group
Topography:	
Inferred Groundwater Flow Direction:	To the south towards the Susquehanna River
Site Inspection Notes	
Due to lack of access to the property site inspections were performed by viewing the site from adjacent roadways/parking lots. No interior inspections were performed. Recent snowfall prevented ground surfaces from being observed. No surface water features, hazardous substances, petroleum products or storage of hazardous materials was noted.

There were no documented concerns identified in the database report, and historic research indicated did not indicate industrial use. It is believed that this property was used by the police and fire departments. This type of use would most likely include the presence of fuel tanks (for equipment), and while no spill reports exist, the past/present existence of tanks cannot be completely ruled out without further investigation, which is needed to determine the likelihood of contamination on the site.

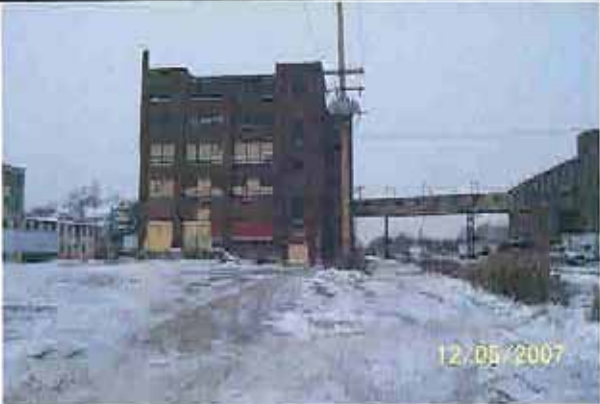
Site Photograph:

Date: 12/5/2007
Current Use of Property	
The property appears to be vacant currently. It is also currently for sale. It is located in an industrial area, and past usages have included a railroad depot (including fuel supply for the trains), building supply, and a book company.	
Adjacent Land Use	
North: RR tracks, vacant warehouse buildings.	South: Vacant buildings at 147 Grand Ave.
East: Vacant lot, residential	West: Commercial/Industrial.
Physical Features	
<i>Soil Information:</i>	Cut and Fill Lands, gravelly and silty materials
<i>Surficial Geology:</i>	Outwash Sand and Gravel
<i>Geologic/Bedrock:</i>	Cashaqua Shale of the Sonyea Group
<i>Topography:</i>	
<i>Inferred Groundwater Flow Direction:</i>	To the south towards the Susquehanna River
Site Inspection Notes	
Due to lack of access to the property site inspections were performed by viewing the site from adjacent roadways/parking lots. No interior inspections were performed. Recent snowfall prevented ground surfaces from being observed. No surface water features, hazardous substances, petroleum products or storage of hazardous materials was noted.

While there were no reports associated with this property in the database report, historically the property was used for industrial purposes. Given the past usage, as well as its presence in a historically industrial area, the potential for soil/groundwater contamination at this site does exist.

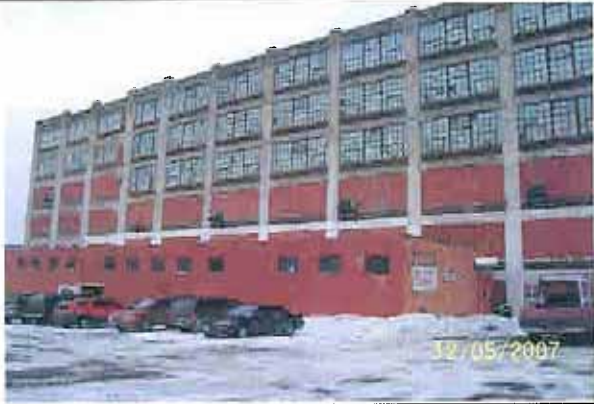
Date: 12/5/2007	
Current Use of Property	
TK Lawn and Hardware, and TK Storage occupy the property currently. Information from a previous Phase I ESA indicates that a photographic film producer was the past use.	
Adjacent Land Use	
North: Residences, fire station, restaur:	South: Residences, railroad corridor, parking lot
East: Vacant building, parking area	West: Indian Valley Industries
Physical Features	
Soil Information:	Cut and Fill Lands, gravelly and silty materials
Surficial Geology:	Outwash Sand and Gravel
Geologic/Bedrock:	Cashaqua Shale of the Sonyea Group
Topography:	
Inferred Groundwater Flow Direction:	To the south towards the Susquehanna River
Site Inspection Notes	
Due to lack of access to the property site inspections were performed by viewing the site from adjacent roadways/parking lots. No interior inspections were performed. Recent snowfall prevented ground surfaces from being observed. No surface water features, hazardous substances, petroleum products or storage of hazardous materials was noted.

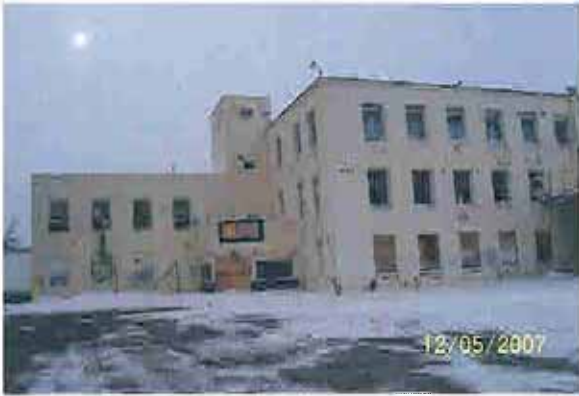
Site Photograph:

Date: 12/5/2007
Current Use of Property	
The property is currently vacant. A sign on the building indicates that it was used for a skate/BMX bike park after the industry left.	
Adjacent Land Use	
North: 46 Corliss Ave (vacant buildings)	South: Railroad tracks, residential.
East: Industrial use at 25 Ozalid Dr.	West: Parking area, 48 Corliss ave.
Physical Features	
Soil Information:	Cut and Fill Lands, gravelly and silty materials
Surficial Geology:	Outwash Sand and Gravel
Geologic/Bedrock:	Cashaqua Shale of the Sonyea Group
Topography:	
Inferred Groundwater Flow Direction:	To the south towards the Susquehanna River
Site Inspection Notes	
Due to lack of access to the property site inspections were performed by viewing the site from adjacent roadways/parking lots. No interior inspections were performed. Recent snowfall prevented ground surfaces from being observed. No surface water features, hazardous substances, petroleum products or storage of hazardous materials was noted.

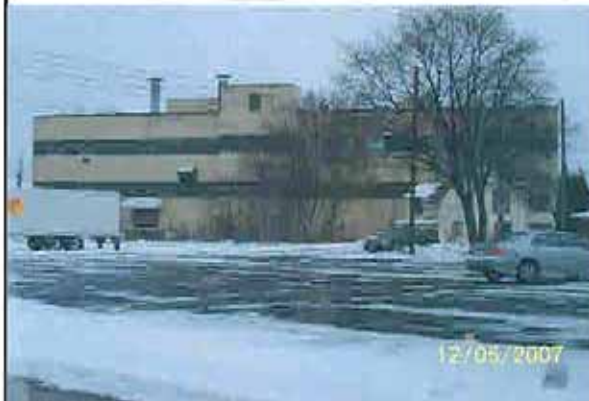
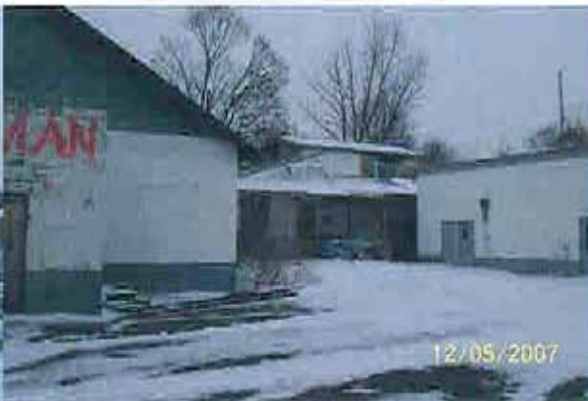
Date: 12/5/2007	
Current Use of Property	
The property did not have any signs indicating its use. It is known that this parcel was once occupied by a coated paper company. Currently it appears to be vacant. It contains one large building and a smaller guard house/kiosk type building, as well as several outbuildings south of the main industrial building. The outbuildings are in poor condition.	
Adjacent Land Use	
North: Residential	South: Railroad Tracks
East: Parking and Residential	West: Corliss Avenue industrial properties
Physical Features	
<i>Soil Information:</i>	Cut and Fill Lands, gravelly and silty materials
<i>Surficial Geology:</i>	Outwash Sand and Gravel
<i>Geologic/Bedrock:</i>	Cashaqua Shale of the Sonyea Group
<i>Topography:</i>	
<i>Inferred Groundwater Flow Direction:</i>	To the south towards the Susquehanna River
Site Inspection Notes	
Due to lack of access to the property site inspections were performed by viewing the site from adjacent roadways/parking lots. No interior inspections were performed. Recent snowfall prevented ground surfaces from being observed. No surface water features, hazardous substances, petroleum products or storage of hazardous materials was noted.

Historical Atlases	
Source:	Combination Atlas Map of Broome County, 1870.
Description:	No coverage for the site, however areas south and east were already developed.
Listed Spills (Database Search)	
Description:	
This property has several listings in the database report, including leaking underground storage tanks, and spill reports pertaining to those tanks. Additionally a mercury spill was reported within the building during a previous asbestos inspection after the building was abandoned. Waste Oil and mixed unknown chemicals were also reported in a separate spill report. Due to the industrial history as well as the history of chemical releases, the potential for soil/groundwater contamination exists on this site.	
Summary of Environmental Concerns	
This property has several listings in the database report which indicates existing contamination. Due to the spill reports, as well as a known industrial history on the Property, the potential for soil/groundwater contamination exists on this site.

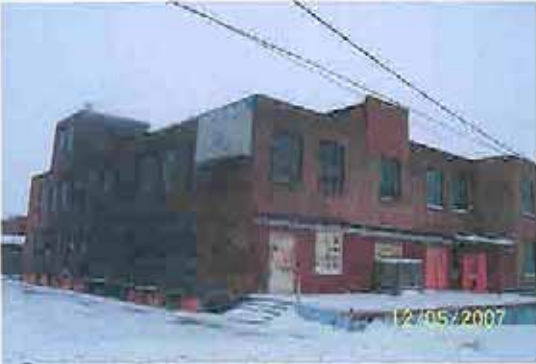
Site Photograph:

Date: 12/5/2007	
Current Use of Property	
The property is current vacant. A sign on the building states "Volunteers of America Thrift Shop"	
Adjacent Land Use	
North: Retail buildings.	South: Large vacant building (59 Lester)
East: Residential	West: Parking facilities, Johnson City PD.
Physical Features	
Soil Information:	Cut and Fill Lands, gravelly and silty materials
Surficial Geology:	Outwash Sand and Gravel
Geologic/Bedrock:	Cashaqua Shale of the Sonyea Group
Topography:	
Inferred Groundwater Flow Direction:	To the south towards the Susquehanna River
Site Inspection Notes	
Due to lack of access to the property site inspections were performed by viewing the site from adjacent roadways/parking lots. No interior inspections were performed. Recent snowfall prevented ground surfaces from being observed. No surface water features, hazardous substances, petroleum products or storage of hazardous materials was noted.

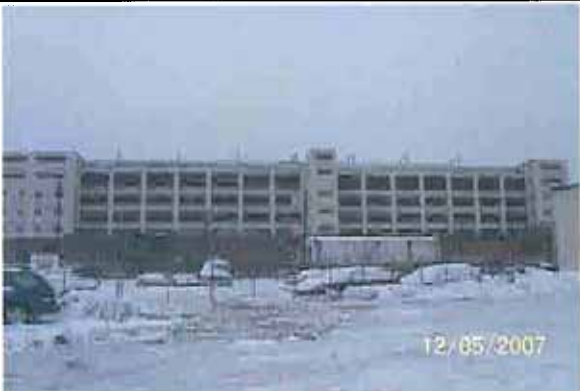
Date: 12/5/2007	
Current Use of Property	
The property is currently occupied by the TK storage facility, and by TK Auto Outlet . Information from a previous Phase I ESA indicates that it was once occupied by Endicott-Johnson.	
Adjacent Land Use	
North: Railroad corridor, former lumber building	South: Residential properties, bar, vacant building
East: Country Valley Industries, Vacant buildings	West: Municipal parking lot, commercial buildings
Physical Features	
Soil Information:	Cut and Fill Lands, gravelly and silty materials
Surficial Geology:	Outwash Sand and Gravel
Geologic/Bedrock:	Cashaqua Shale of the Sonyea Group
Topography:	
Inferred Groundwater Flow Direction:	To the south towards the Susquehanna River
Site Inspection Notes	
Due to lack of access to the property site inspections were performed by viewing the site from adjacent roadways/parking lots. No interior inspections were performed. Recent snowfall prevented ground surfaces from being observed. No surface water features, hazardous substances, petroleum products or storage of hazardous materials was noted.

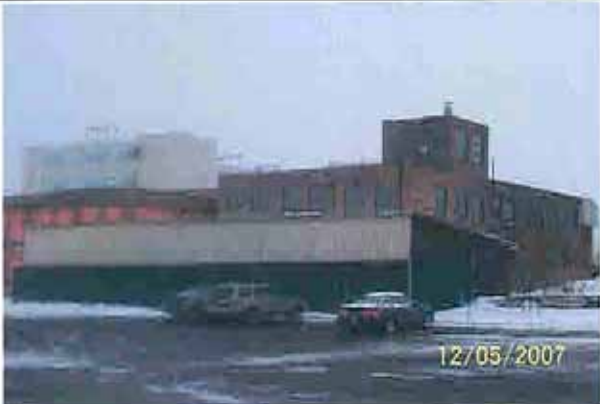
Site Photograph:					
<p>Note: The property is almost entirely taken up by the shed in the foreground of the picture. Neither the parking lot nor the brick building in the background are part of the parcel.</p>

Date: 12/5/2007	
Current Use of Property	
The property is almost entirely occupied by a small shed adjacent to the building at 19 Avenue B. It does not appear to have a documented use, and is "landlocked" in the sense that it is bounded on all sides by neighboring properties and has no direct street access.	
Adjacent Land Use	
North: Vacant land, also retail and residential uses.	South: Helen Drive, 19 Ave B, warehouse buildings.
East: Vacant brick building at 19 Avenue B.	West: Parking for the Johnson City Justice Building.
Physical Features	
<i>Soil Information:</i>	Cut and Fill Lands, gravelly and silty materials
<i>Surficial Geology:</i>	Outwash Sand and Gravel
<i>Geologic/Bedrock:</i>	Cashaqua Shale of the Sonyea Group
<i>Topography:</i>	
<i>Inferred Groundwater Flow Direction:</i>	To the south towards the Susquehanna River
Site Inspection Notes	
Due to lack of access to the property site inspections were performed by viewing the site from adjacent roadways/parking lots. No interior inspections were performed. Recent snowfall prevented ground surfaces from being observed. No surface water features, hazardous substances, petroleum products or storage of hazardous materials was noted.

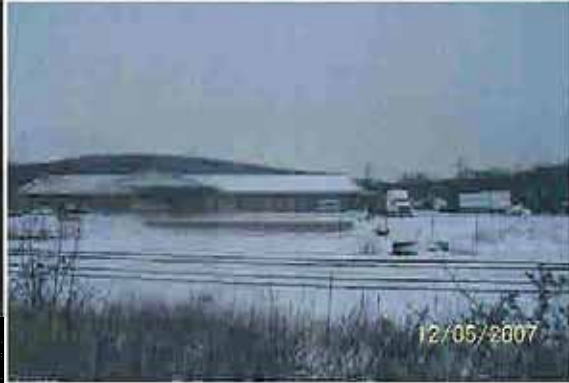
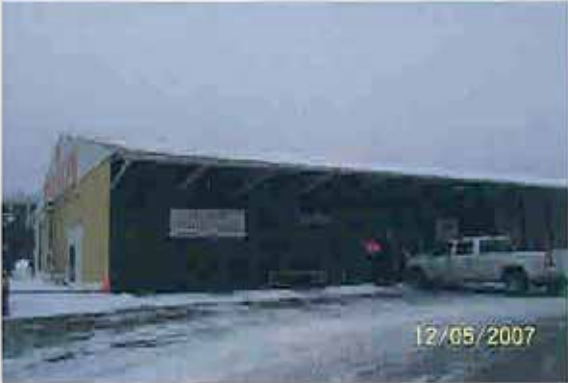
Date: 12/5/2007
Current Use of Property	
The property is currently occupied by Hank's Warehouse, and the Nu Lock Towing yard. The main building is only partially occupied by Hank's. Research indicates that it was once a lumber yard, and prior to that was an area once occupied by Endicott Johnson. Currently the remainder of the property contains some junk storage, and there are several large trucks parked on site.	
Adjacent Land Use	
North: Railroad Tracks, warehouse building.	South: Stream, Residential
East: CFJ park	West: Residential
Physical Features	
Soil Information:	Cut and Fill Lands, gravelly and silty materials
Surficial Geology:	Outwash Sand and Gravel
Geologic/Bedrock:	Cashaqua Shale of the Sonyea Group
Topography:	
Inferred Groundwater Flow Direction:	To the south towards the Susquehanna River
Site Inspection Notes	
Due to lack of access to the property site inspections were performed by viewing the site from adjacent roadways/parking lots. No interior inspections were performed. Recent snowfall prevented ground surfaces from being observed. No surface water features, hazardous substances, petroleum products or storage of hazardous materials was noted.

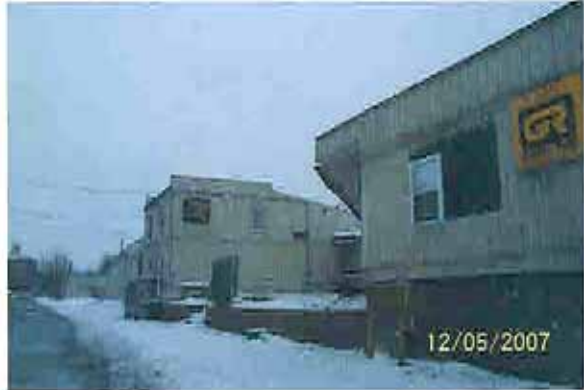
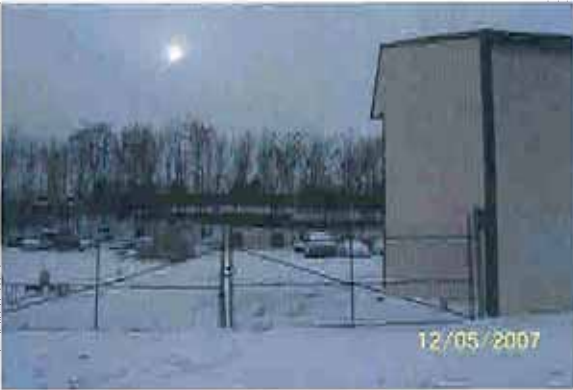
While this site was not identified by the database report, the current use of the property contains large amounts of junk, including junk vehicles. While the majority of the site was unable to be observed, it is unknown what chemicals/hazardous materials could be present within the junk piles or within the structures. Given the current use, the potential for environmental contamination does exist, but further research is needed to determine the status of this property.
